### WHITE'S POINT RESERVATION, BASE END STATIONS (B"1-B"6)

HAER No. CA-185

**Location:** White's Point Reservation  
Bounded by Voyager Circle and Mariner Drive  
San Pedro, Los Angeles County, California

**Date of Construction:** 1917-1918. Altered in the early 1930s (World War II)

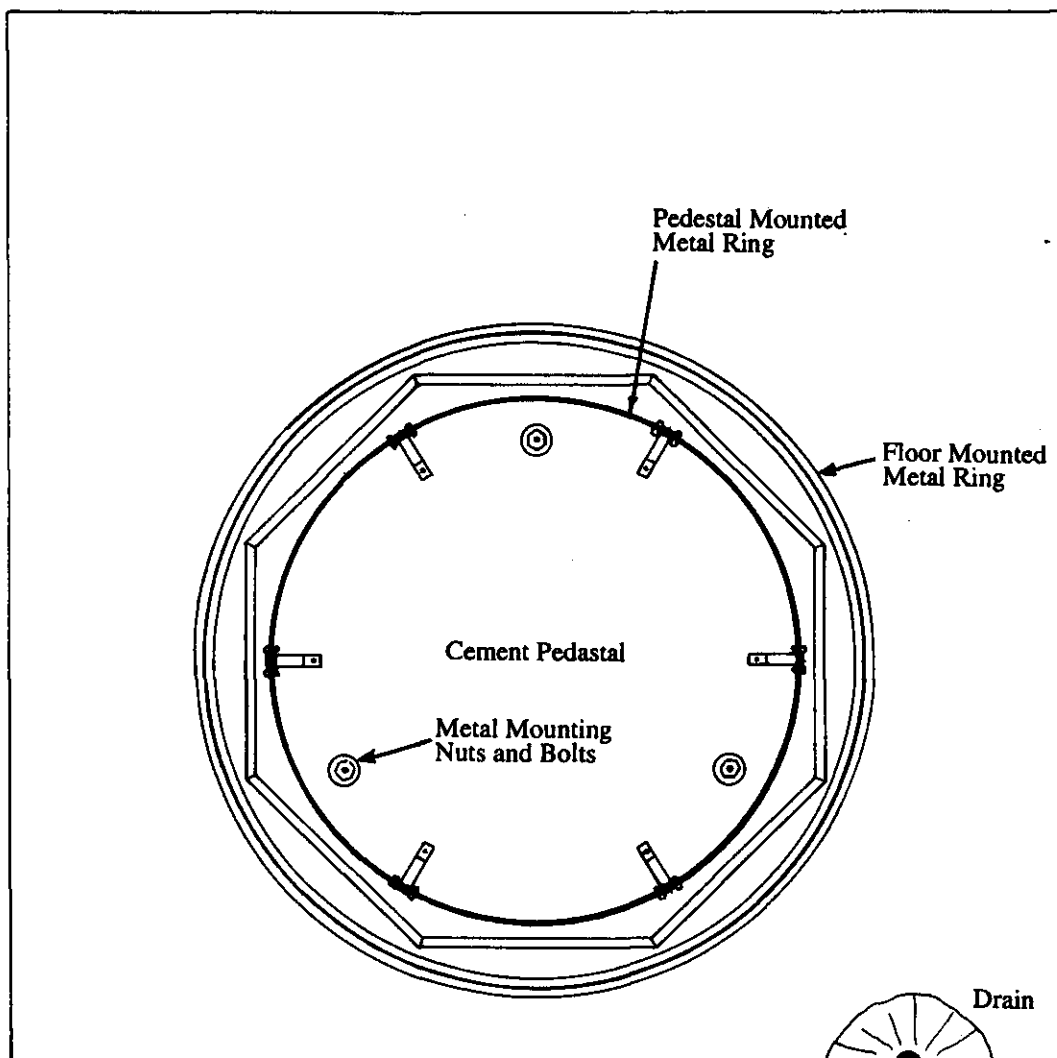
Figure 22  
Base End Station B"6 (Farley)  
Floor and Instrument Pedestal

The pedestal on the floor of B"6 is in excellent condition (Figure 22; see Photograph F-8). The mounting bolts with nuts are in place, a mounting ring is present on the top of the pedestal, and a second metal ring surrounding the pedestal is mounted on the floor. The upper metal ring is held in place with a series of six metal brackets. These brackets are screwed into the cement pedestal and attached to the inner face of the ring elevating the ring 4" from the pedestal. This station and B"2 are the only stations that retain these elements. As seen in B"2, this pair of metal rings supported the wooden bench that the observers sat upon to view through the instrument.
